PHOTOGRAPHIC INTELLIGENCE REPORT

CLA/PIR 65108

DATE APRIL 1966

A STUDY OF THE NORTH VIETNAMESE RAIL LINE SOUTH OF HANOI

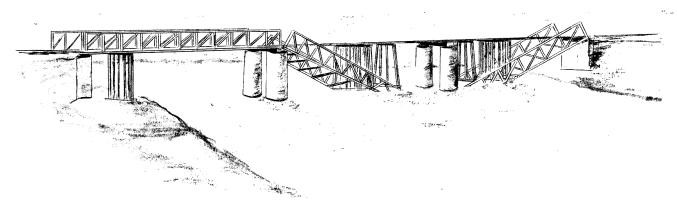
CIA/PIR - 65108 FIGURE 30

This was originally a 360', 3 span, steel, half-through truss bridge with concrete piers. Two spans were dropped as a result of US airstrikes. The bridge has been repaired with a wood, deck-beam structure supported by wooden lattice towers (See figure 30). The capacity of this bridge is approximately 7 to 10 tons total load per span.

TAM DA RR BRIDGE

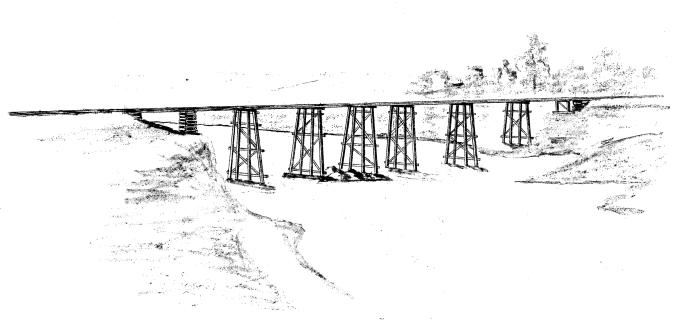
CIA/PIR - 65108 FIGURE 40

This was originally a single-span, steel, through truss bridge with masonry abutments. US airstrikes dropped the span, and a wooden trestle-type bridge was reconstructed over the wreckage of the old bridge. The replacement bridge was destroyed by US airstrikes in February 1966. Since that time a timber trestle bypass bridge and rail approaches have been constructed about 100 yards west of the bridge (See figure 40). This bypass is now serviceable. The maximum safe load per span is approximately 10 tons.

BAI DUC THON RR BY-PASS BRIDGE

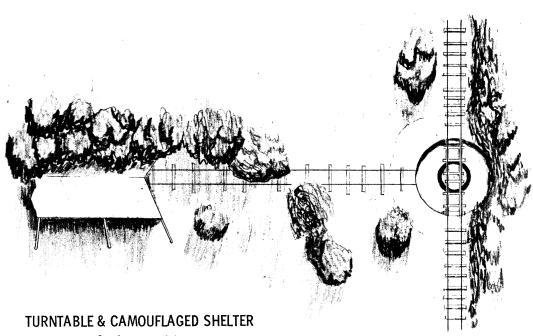
CIA/PIR - 65108 FIGURE 41

Figure 41 is a drawing of a turntable located at 18 06N - 105 46E. This turntable is the only one of four imaged along this segment of the rail line which has a short spur leading away from the main line to a camouflaged shelter. The other three turntables serve only to reverse the direction of converted trucks or rolling stock.
